TECHNICAL NOTE 3269

ADDITIONAL STATIC AND FATIGUE TESTS OF HIGH-STRENGTH  
ALUMINUM-ALLOY BOLTED JOINTS

By E. C. Hartmann, Marshall Holt, and I. D. Eaton

Aluminum Company of America

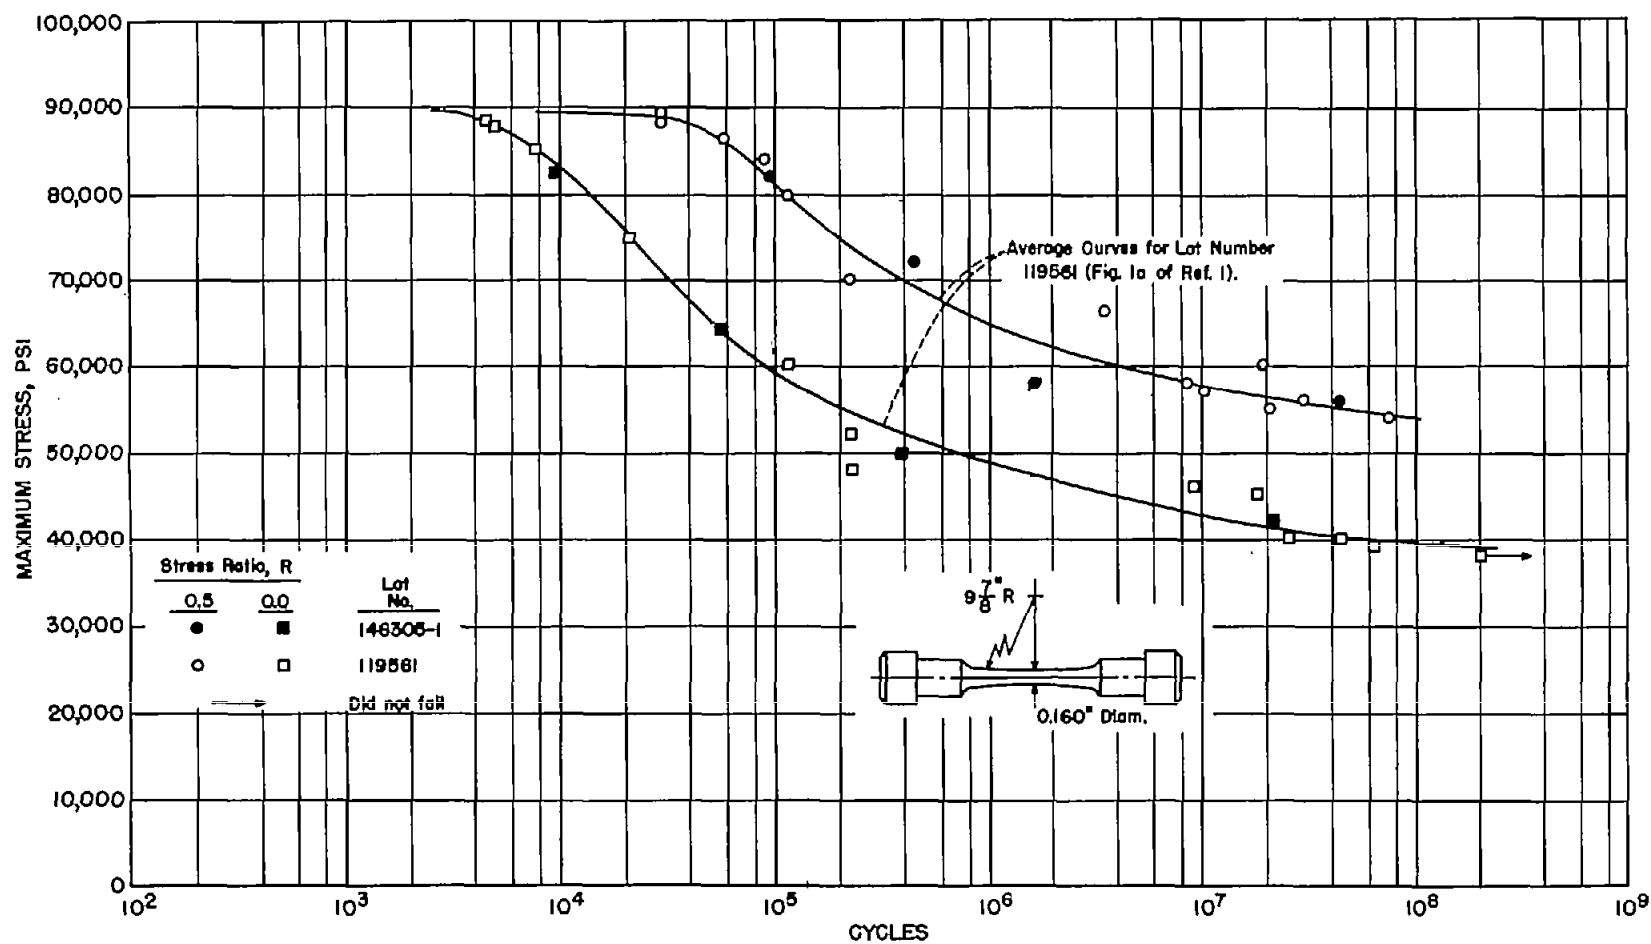
Figure 1.- Direct tension-compression fatigue data for 75S-T6 extruded bar  
 (1 1/4 by 4 inches).

Direct-stress fatigue tests were made on polished round specimens as described in reference 1 to determine the degree of agreement of basic fatigue strengths for the old and new lots of 75S-T6 and 24S-T4 aluminum alloys. The fatigue test results for the two lots of each alloy are plotted in figures 1 and 2 where it is seen that the direct-stress fatigue strengths for the two lots of 75S-T6 compare very well and that the fatigue strengths of the new lot of 24S-T4 are slightly higher than the results obtained on the original lot, but such small differences are not considered significant in light of the data in reference 3.

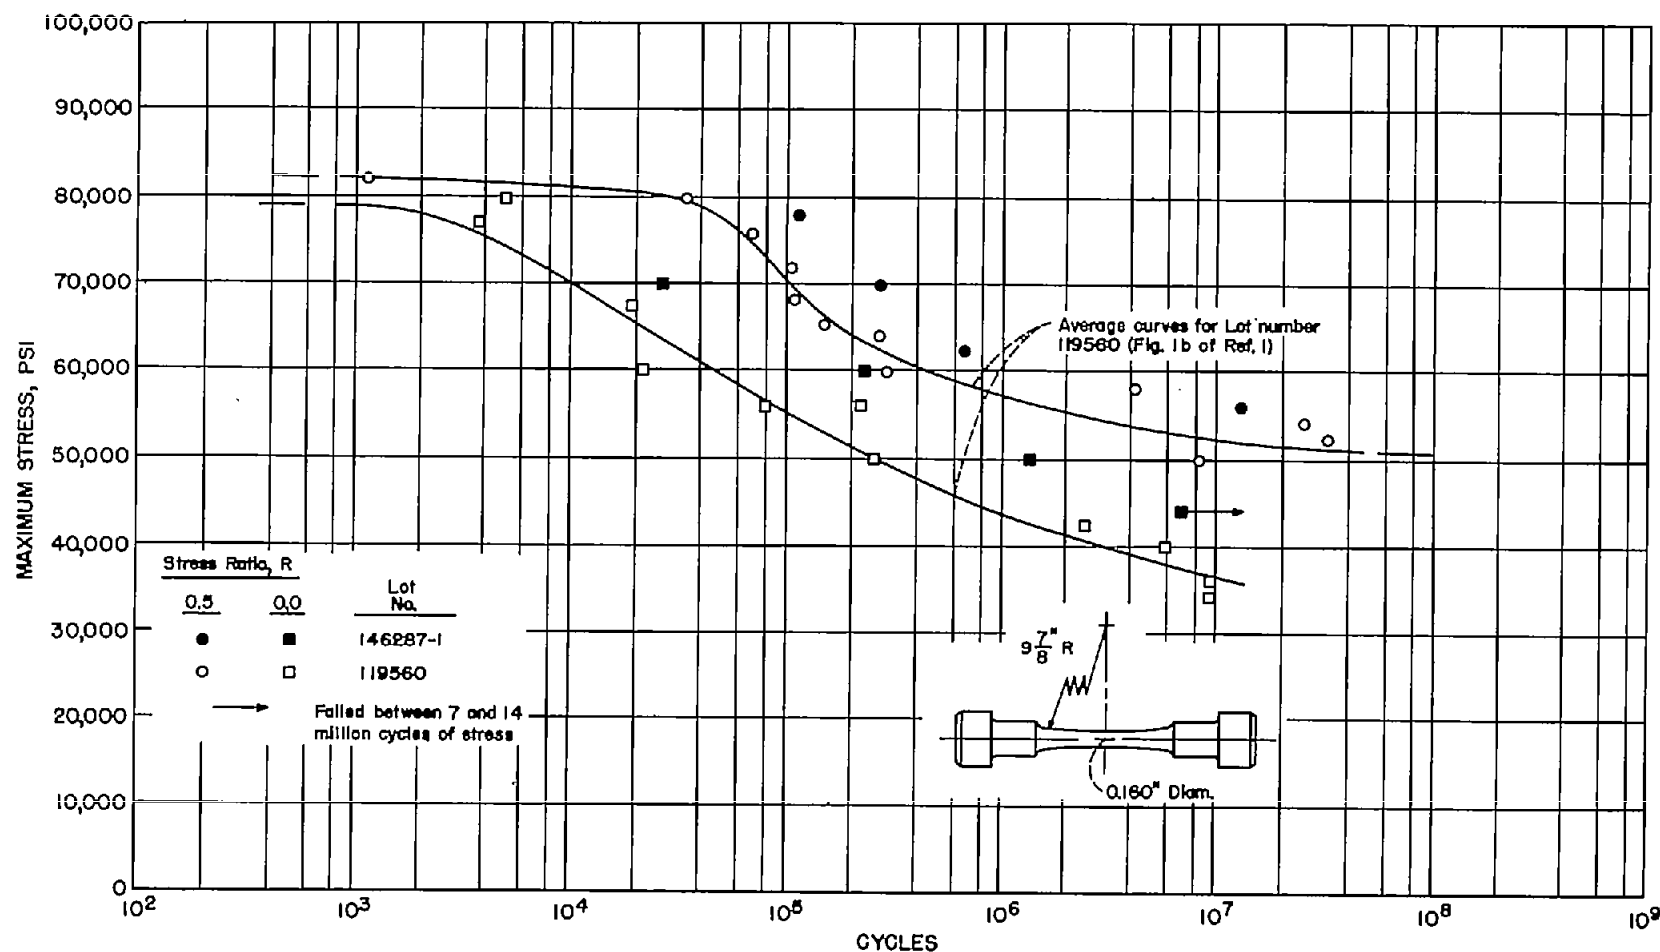
Figure 2.- Direct tension-compression fatigue data for 24S-T4 extruded bar ( $\frac{1\frac{1}{4}}{4}$  by 4 inches).

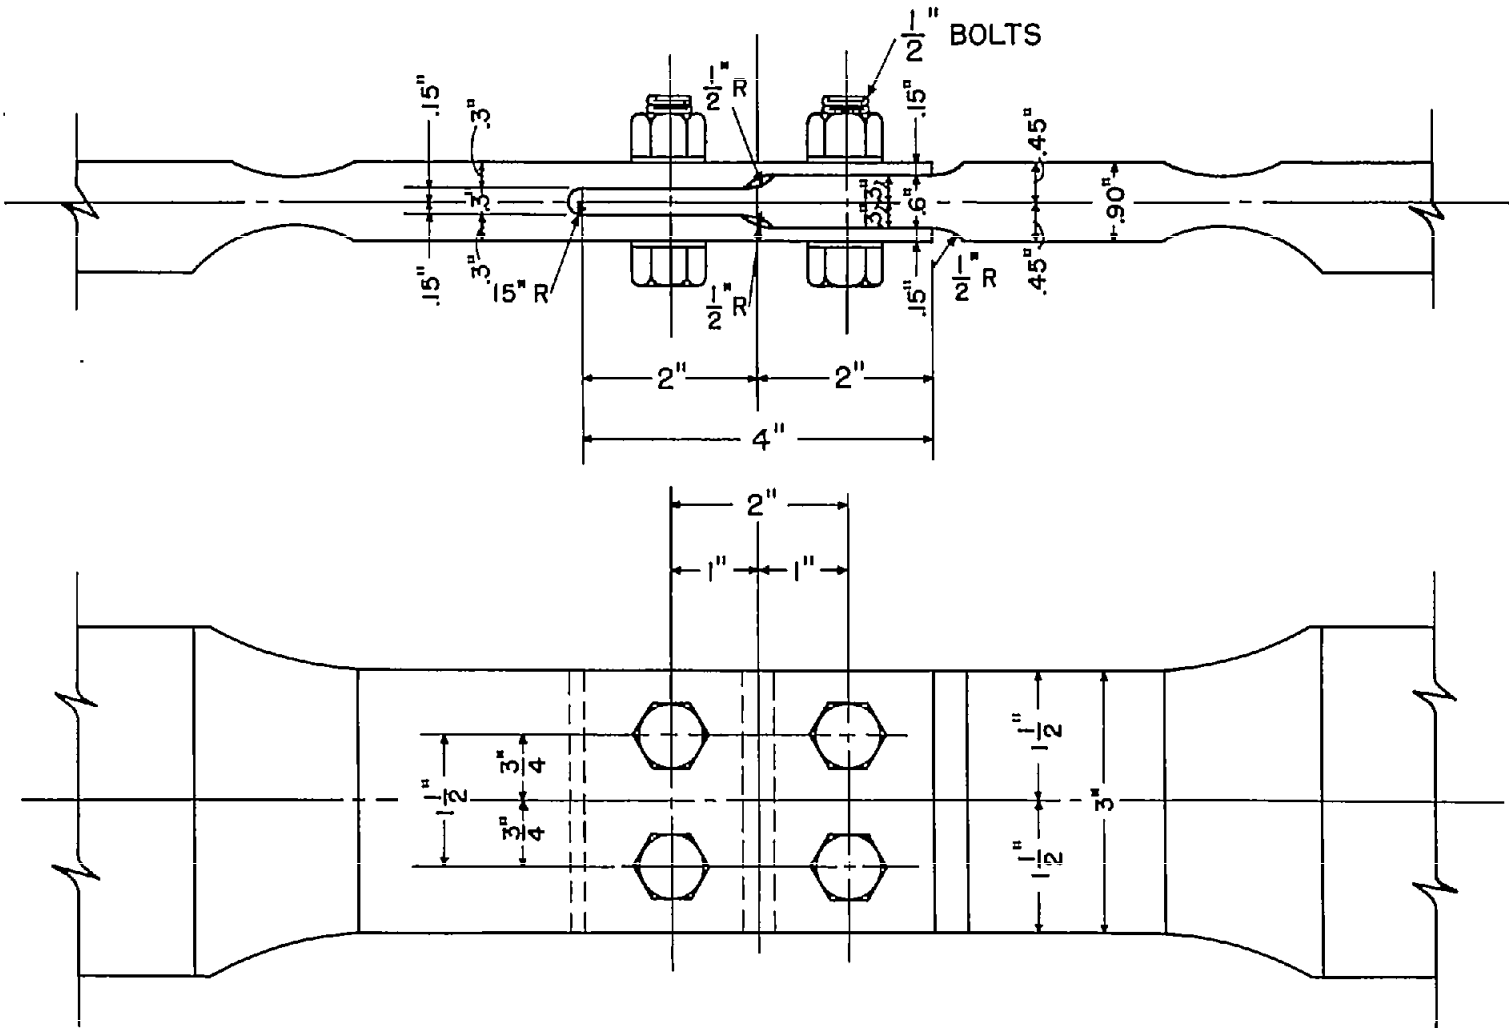
Figure 3.- Stepped double-shear joint specimen.

The stepped double-shear joint, the new joint type used in this investigation, is shown in figure 3. It can be seen that the net-section area is 1.2 square inches at the first row of bolt holes and 0.6 square inch at the second row of bolt holes. The bolt holes were reamed to 0.0010 to 0.0020 inch under the measured bolt diameter.

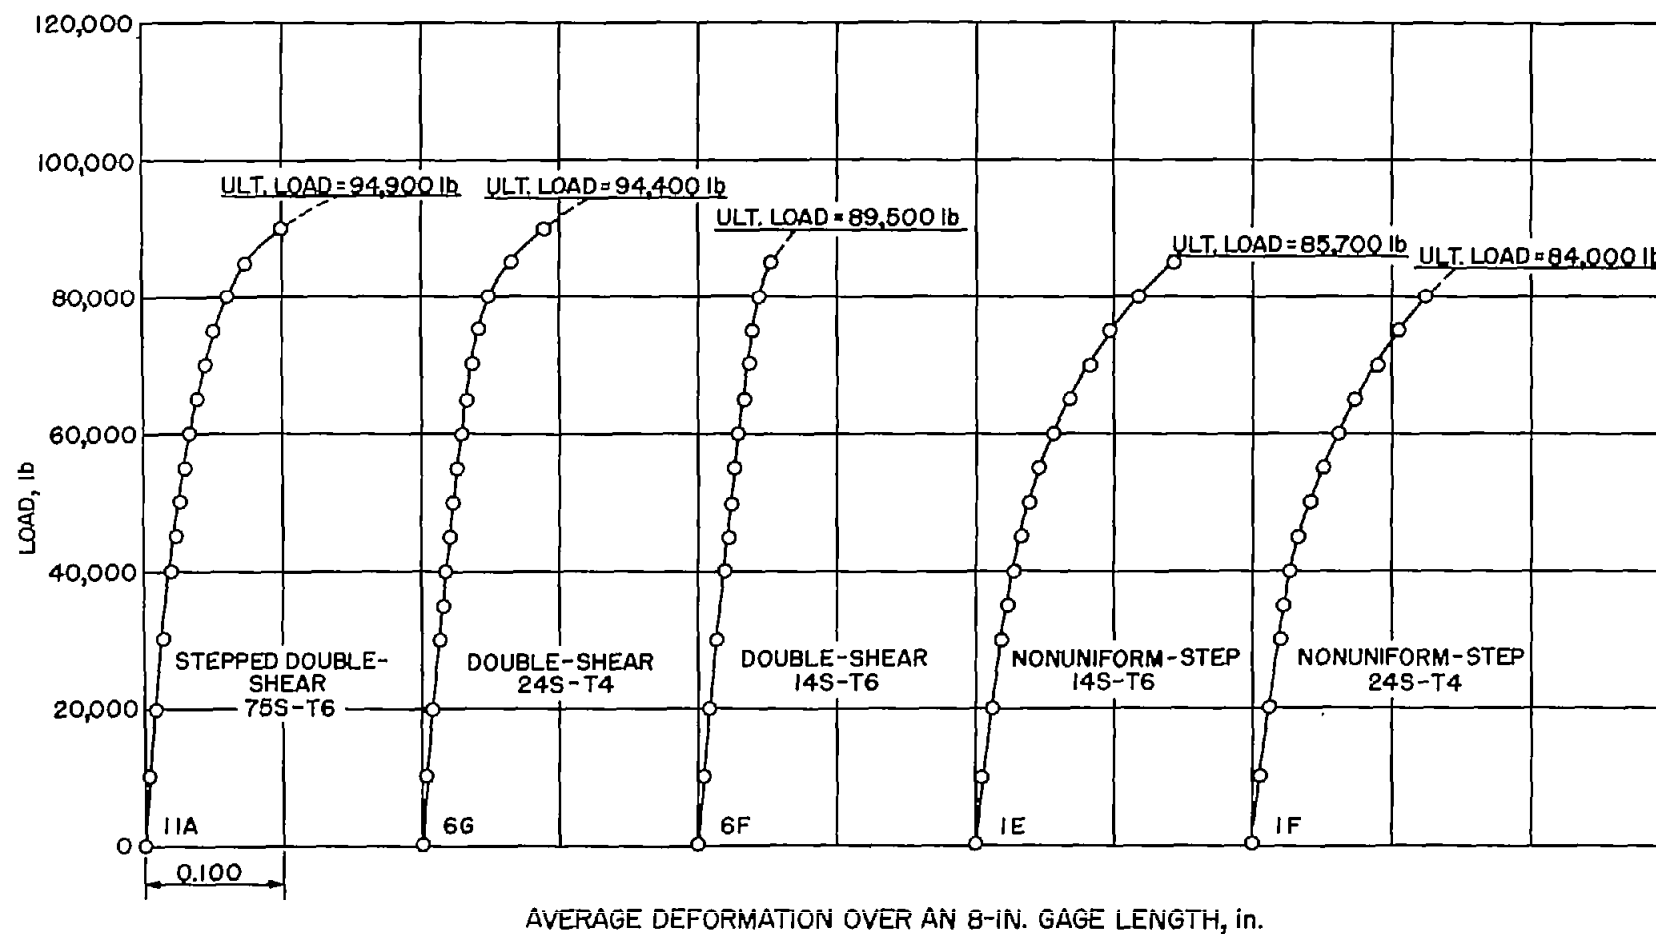
Figure 4.- Curves of static tensile load against deformation for high-strength aluminum-alloy bolted joints.

The results of the additional static tests are presented in figure 4 and are summarized in table II, together with the results for the 75S-T6 nonuniform-step and double-shear joints taken from table IV of reference 1.

The stepped double-shear joint, the new joint design tested in this investigation, withstood an ultimate load of 94,900 pounds, in other words, 29,200 pounds per pound of joint weight. The deformation in an 8-inch gage length under a load of 16,000 pounds was 0.0060 inch. When compared with the static test results of the other 75S-T6 aluminum-alloy joints given in reference 1, it is found that the ultimate load of the stepped double-shear joint is lower than that of the double-shear (115,250 pounds), the uniform-step (107,800 pounds), the plain-scarf (107,250 pounds), and the nonuniform-step (100,000 pounds) joints. The ultimate load of the new stepped double-shear joint exceeds the ultimate loads of the bolted-keyed, double-scarf, single-shear, serrated, and clamped-keyed joints. The load per pound of weight and deformation in 8 inches at 16,000-pound load are also intermediate to the values obtained for the other types of 75S-T6 joints.

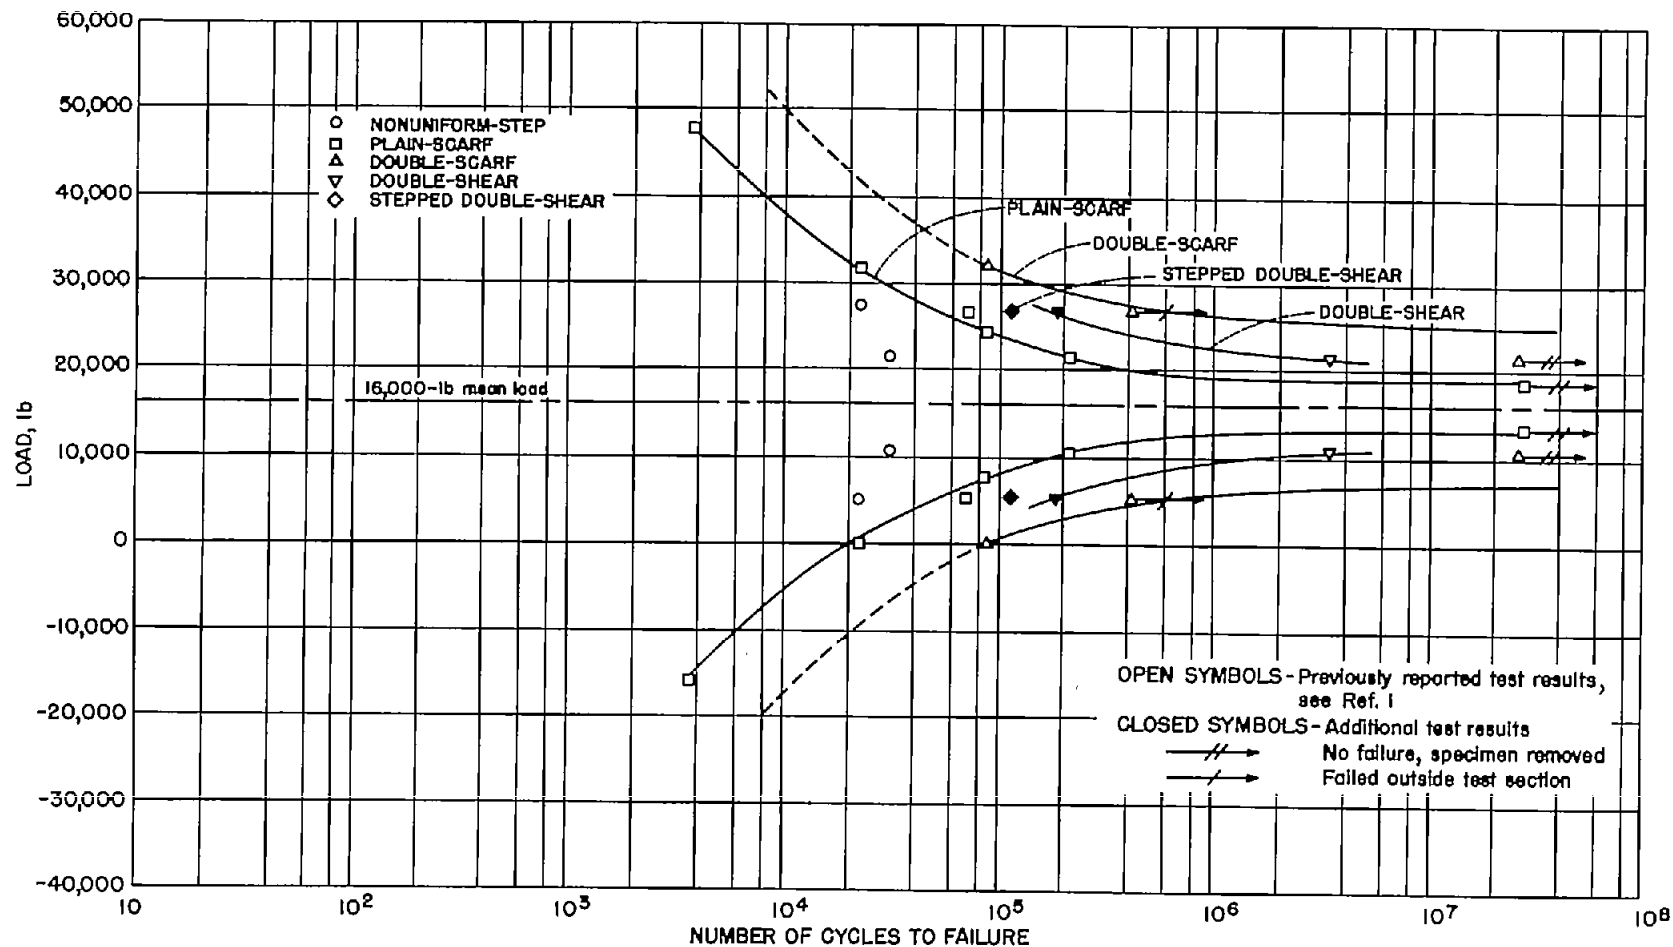
Figure 6.- Direct-stress fatigue curves for 75S-T6 aluminum-alloy bolted joints. Mean load, 16,000 pounds.

The result of the fatigue test on the stepped double-shear joint is included in table IV and is plotted with other results from this and the initial part of the investigation in figure 6. It can be seen that, of the 75S-T6 joints tested, the fatigue life of the stepped double-shear joint (111,400 cycles) is exceeded by that of the double-scarf (418,000 cycles) and double-shear (187,400 cycles) joints. The fatigue fracture shown in figure 7 occurred at the bolt holes in the thin portion of the tongue. No additional fractures were found, either in the tongue or in the outside members.

5. When the fatigue lives of the 75S-T6 joints are compared at a mean load of 16,000 pounds  $\pm$  10,670 pounds (stress ratio, 0.2), the stepped double-shear joint is found to have an intermediate fatigue life. Its fatigue life (111,400 cycles) at these loading conditions is less than the fatigue lives of the double-shear joint (187,400 cycles) and of the double-scarf joint (418,000 cycles).

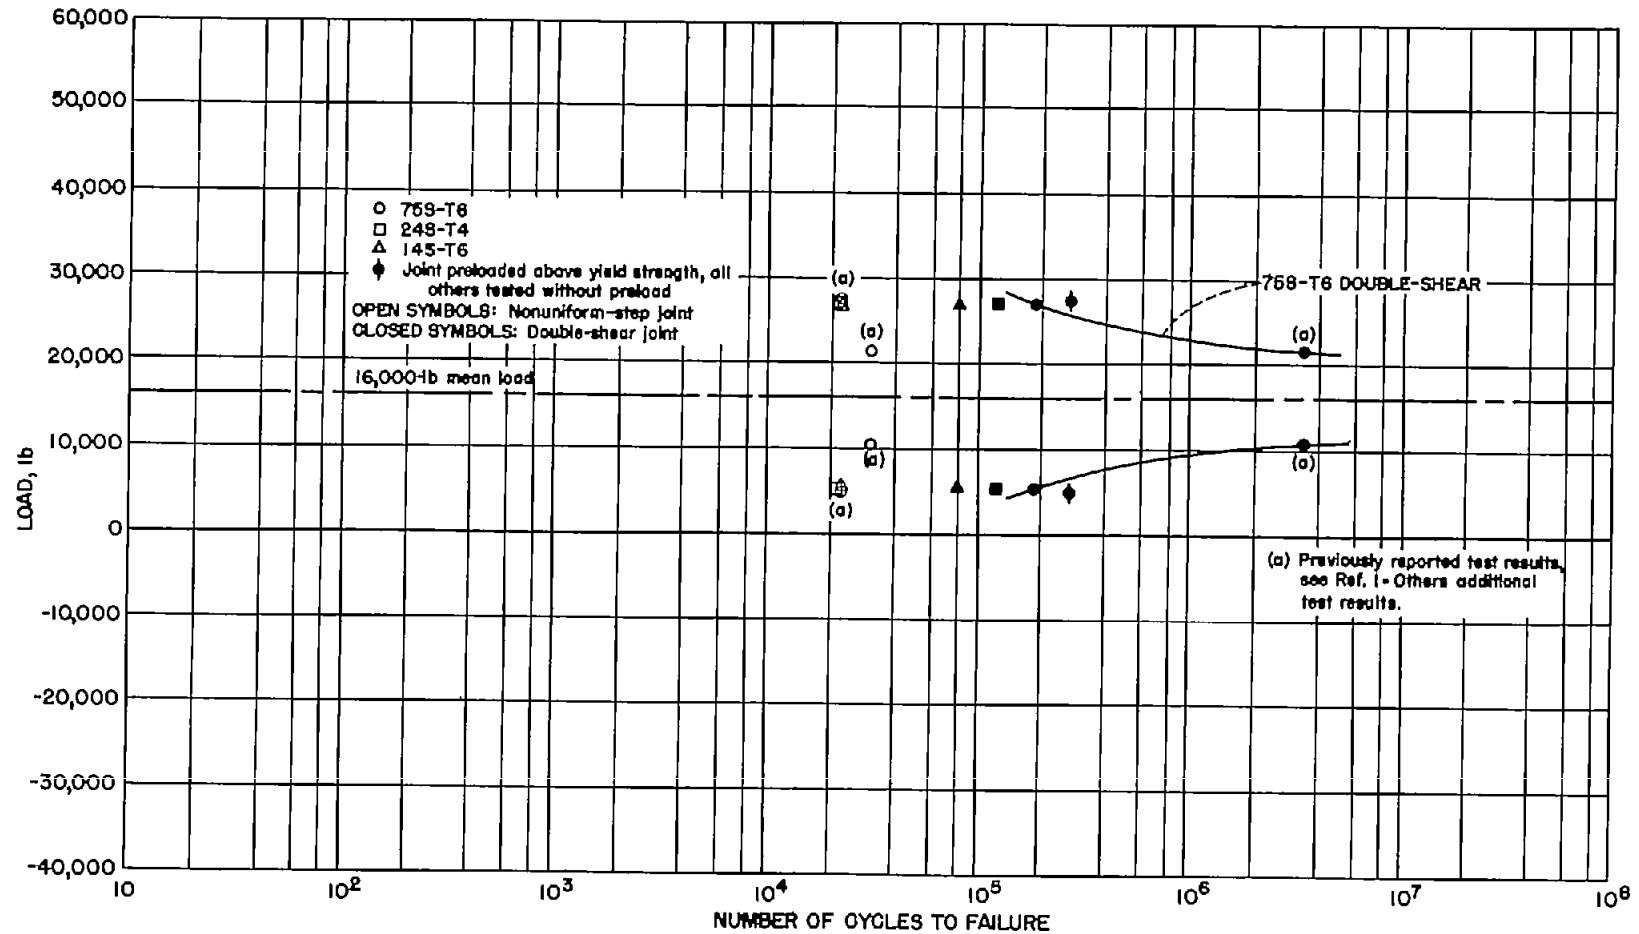
Figure 8.- Direct-stress fatigue curves for double-shear and nonuniform-step joints of 75S-T6, 24S-T4, and 14S-T6 aluminum alloys. Mean load, 16,000 pounds.

Direct-stress fatigue test results for the double-shear and nonuniform-step joints of the three aluminum alloys under consideration are plotted in figure 8 and are included in the summary of table V. For the conditions of 16,000-pound mean load  $\pm 10,670$  pounds, it can be seen that there is no significant difference in the fatigue lives of the nonuniform-step joint in any of the three alloys studied. At a load of 16,000 pounds  $\pm 10,670$  pounds, the fatigue life of the 75S-T6 double-shear joint exceeds the fatigue lives of the 24S-T4 and 14S-T6 double-shear joints by ratios of 1.5:1 and 2.3:1, respectively.

The direct-stress fatigue test results for the plain-scarf and double-shear aluminum-alloy joints, which had been preloaded with a static load, have been plotted in figures 8 and 11 and are included in the summary in table VI. It can be seen that the ratio of the fatigue life of the plain-scarf joint with preload to that of plain-scarf joint without preload is 5.9:1. The preloaded plain-scarf joint failed through the first row of bolt holes similar to the failure of the plain-scarf joint without preload shown in figure 15(b) (joint 2) of reference 1. The like ratio for the double-shear joints was found to be 1.4:1. As shown in figure 15, the preloaded double-shear joint failed in one of

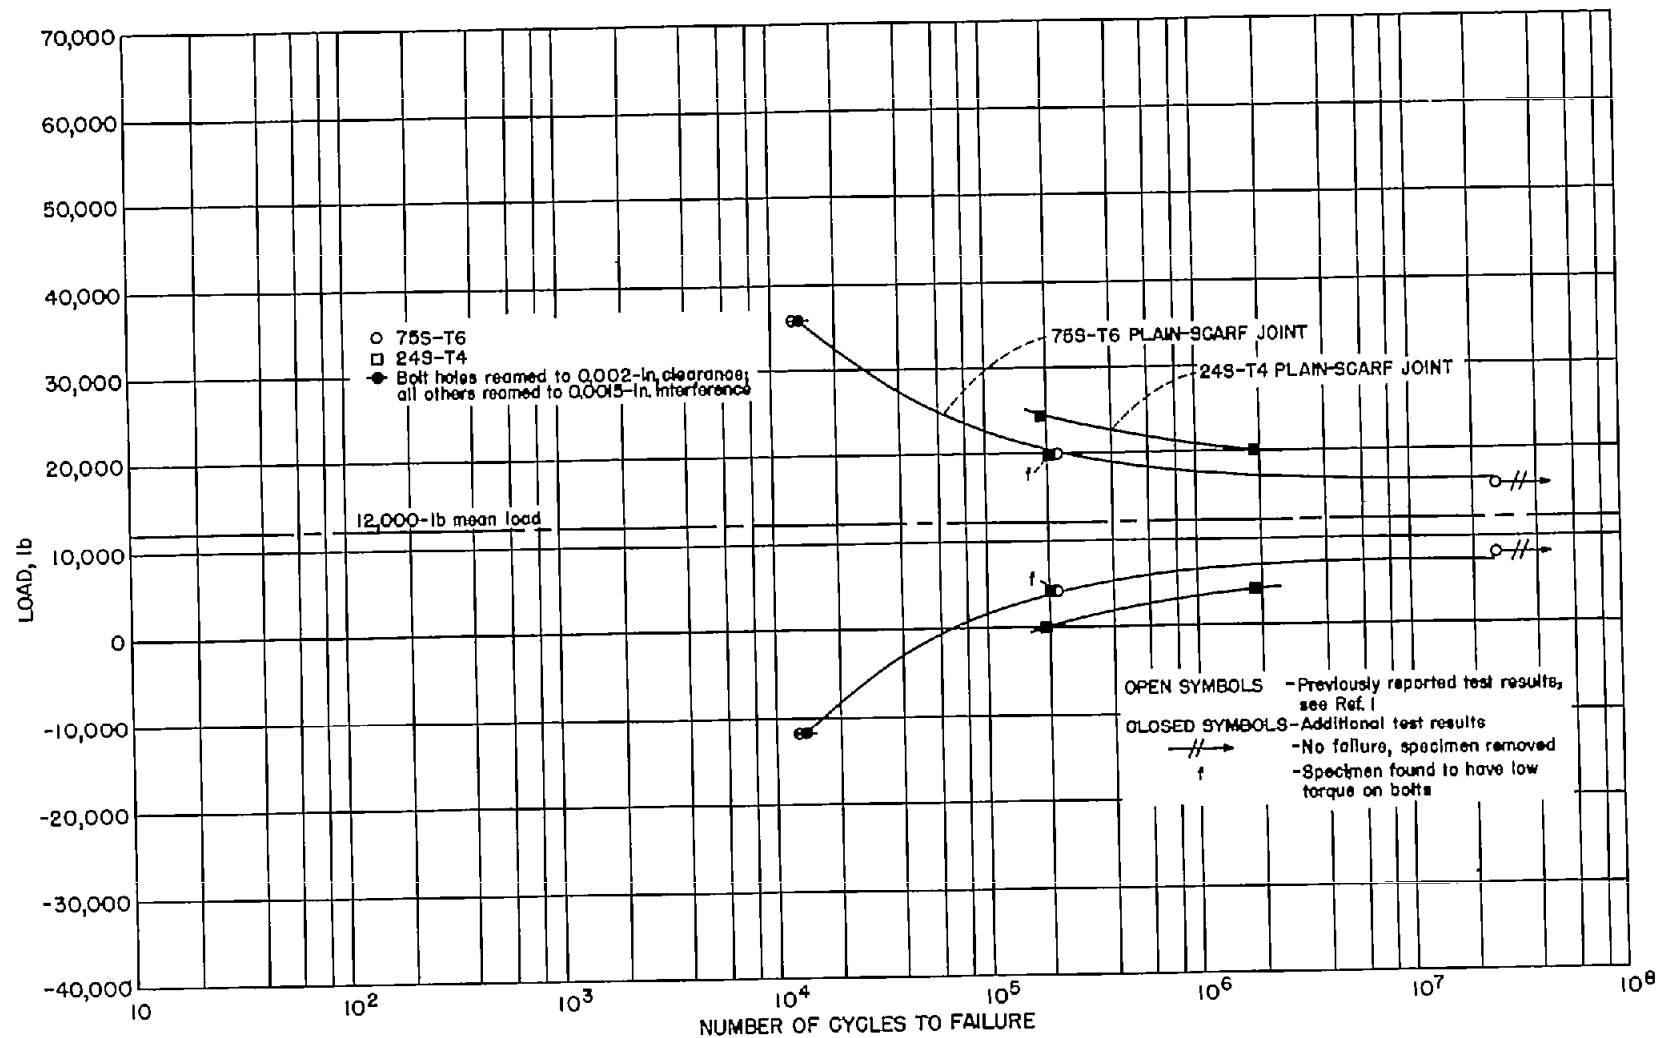
Figure 9.- Direct-stress fatigue curves for plain-scarf joints of 75S-T6 and 24S-T4 aluminum alloy. Mean load, 12,000 pounds.

The summary of results of direct-stress fatigue tests for the plain-scarf joints of 75S-T6, 24S-T4, and 14S-T6 at a mean load of 16,000 pounds and various variable loads, given in table X of reference 1, is extended in table V and figure 9 to include similar comparisons of 75S-T6 and 24S-T4 plain-scarf joints tested with a 12,000-pound mean load and various variable loads. It can be seen that the 24S-T4 plain-scarf joint gives consistently greater fatigue life than the 75S-T6 joint with the ratios of fatigue lives ranging from 1.4:1 to 18.5:1 for the mean loads and stress ratios used in these tests. For like stress ratios the fatigue-life ratios are larger in favor of 24S-T4 at the 12,000-pound mean load than at the 16,000-pound mean load.

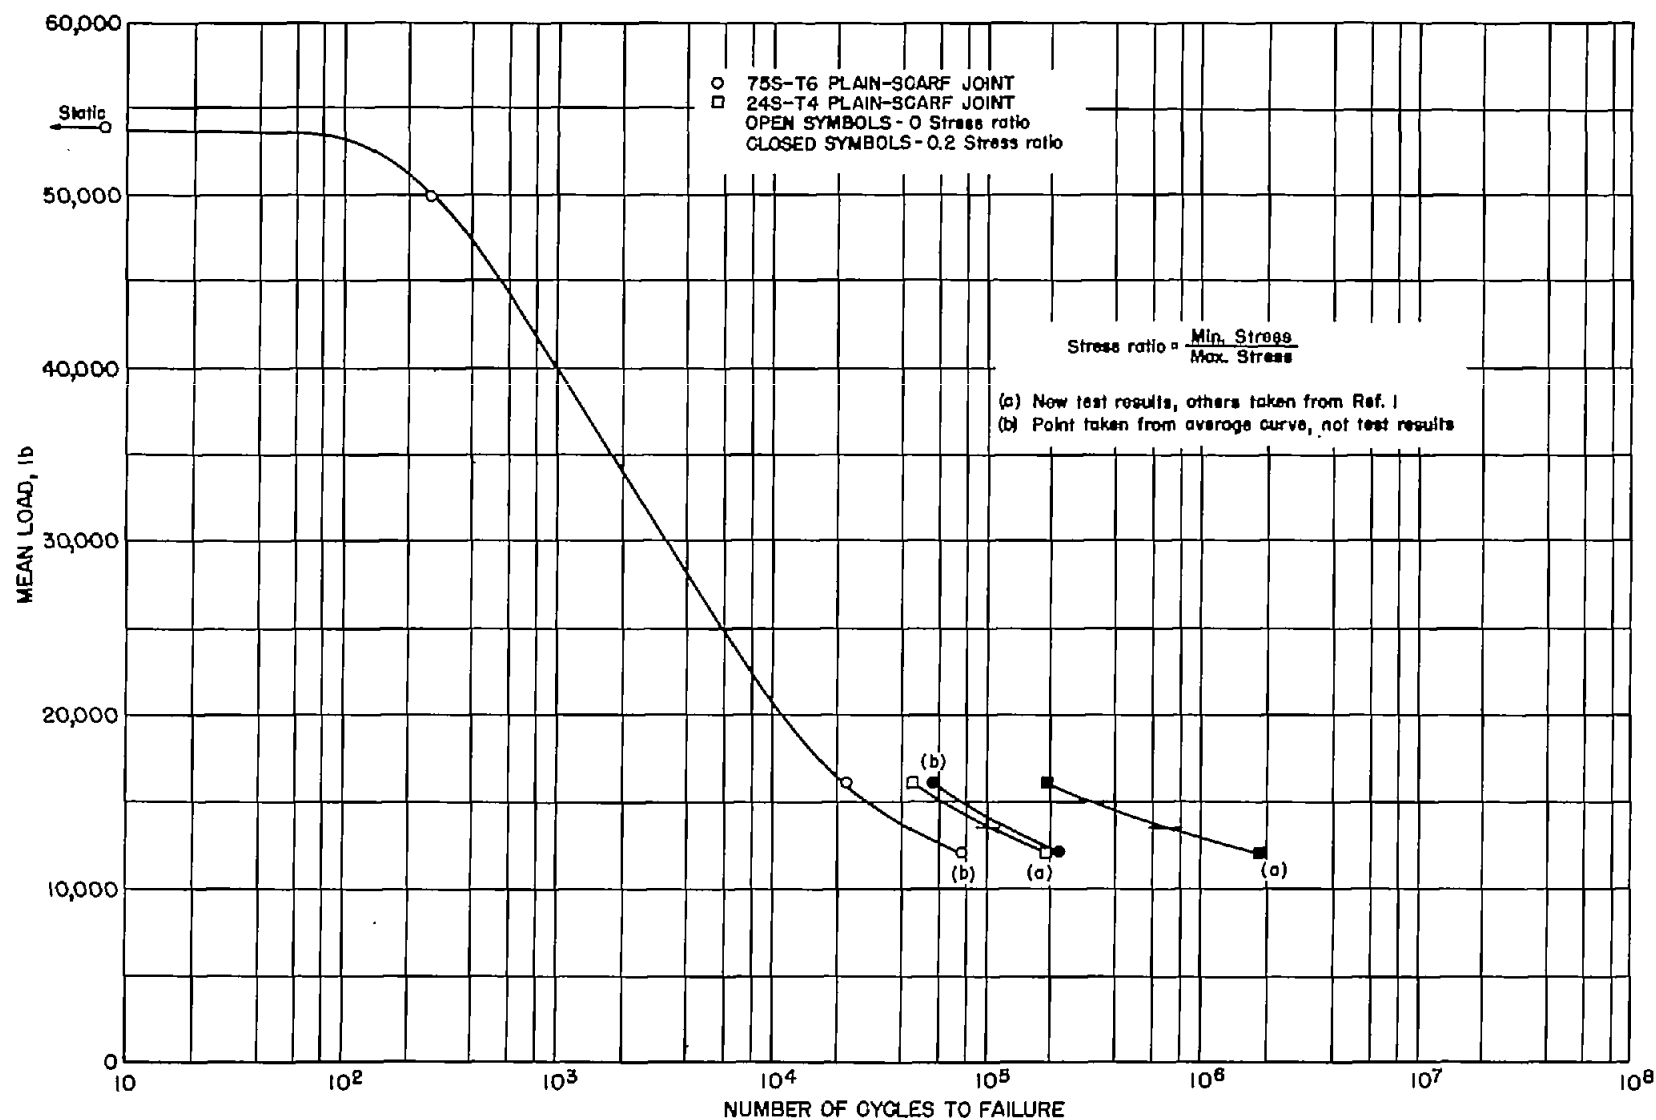
Figure 10.- Direct-stress fatigue curves for plain-scarf joints of 75S-T6 and 24S-T4 aluminum alloy. Mean load versus number of cycles to failure.

The direct-stress fatigue test results for the 75S-T6 and 24S-T4 aluminum-alloy plain-scarf joints at 0 and 0.2 stress ratios have been replotted in figure 10. In order to take care of differences in the static properties of the 75S-T6 and 24S-T4, the fatigue results for the 75S-T6 and 24S-T4 joints should be compared at lower loading conditions for the 24S-T4 joint than for the 75S-T6 joint, that is, on the basis of mean loads of 13,600 pounds and 16,000 pounds, respectively, which are proportional to the ultimate static strengths of the joints. Thus it can be seen in figure 10 that at a mean load of 13,600 pounds the 24S-T4 plain-scarf joint would be expected to fail at 100,000 and 680,000 cycles for the 0 and 0.2 stress ratios, respectively. Included in table V are comparisons of these results with the results for the 75S-T6 plain-scarf joints at the higher mean load of 16,000 pounds and at like stress ratios. The ratio of fatigue lives for the 24S-T4 joint to that of the 75S-T6 joint, when the load on the 24S-T4 joint is adjusted to take account of differences in the static strengths of the joints, is 4.6:1 and 12.4:1 for the 0 and 0.2 stress ratios, respectively. Had the loading on the 24S-T4 joint been adjusted on the basis of the ratio of the ultimate tensile strengths of the materials the mean load would be 14,600 pounds and the ratios of the fatigue life of the 24S-T4 joint to the fatigue life of the 75S-T6 joint would have been 3.2:1 and 6.7:1 for stress ratios of 0 and 0.2, respectively. Further, had the adjustment been made on the basis of the applicable guaranteed minimum values given in reference 2, the adjusted load on the 24S-T4 would have been 13,000 pounds and ratios of fatigue lives of the 24S-T4 to the 75S-T6 joints would have been 6.0:1 and 16.6:1. On the other

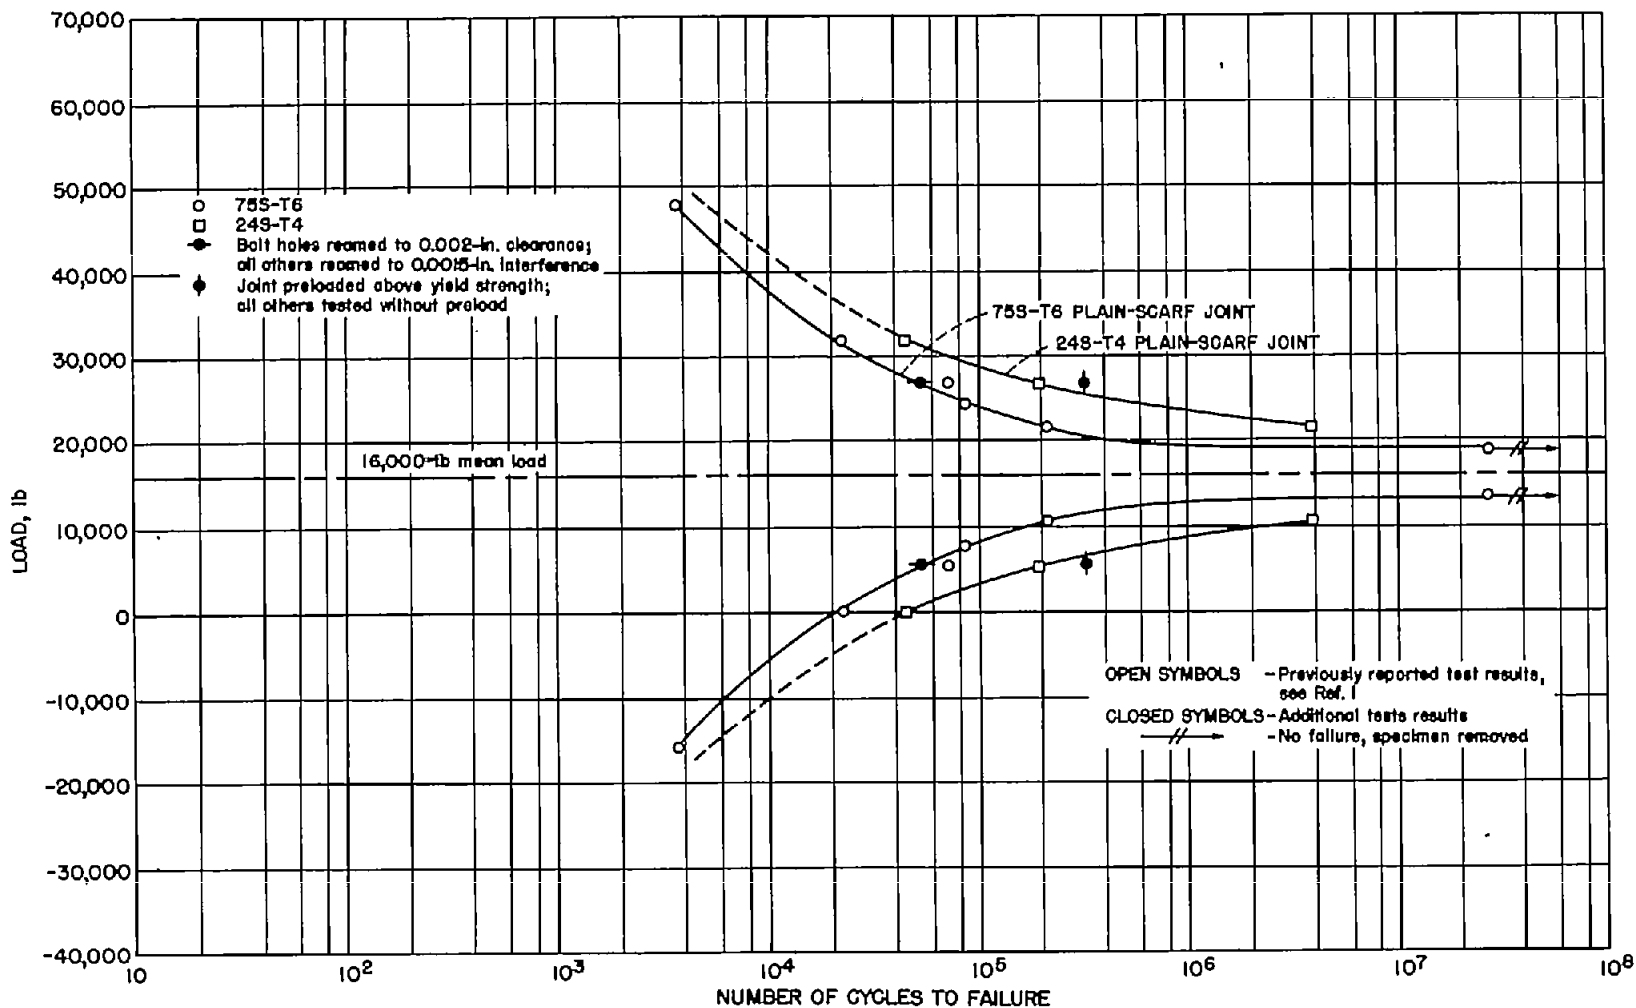
Figure 11.- Direct-stress fatigue curves for plain-scarf joints of 75S-T6 and 24S-T4 aluminum alloy. Mean load, 16,000 pounds.

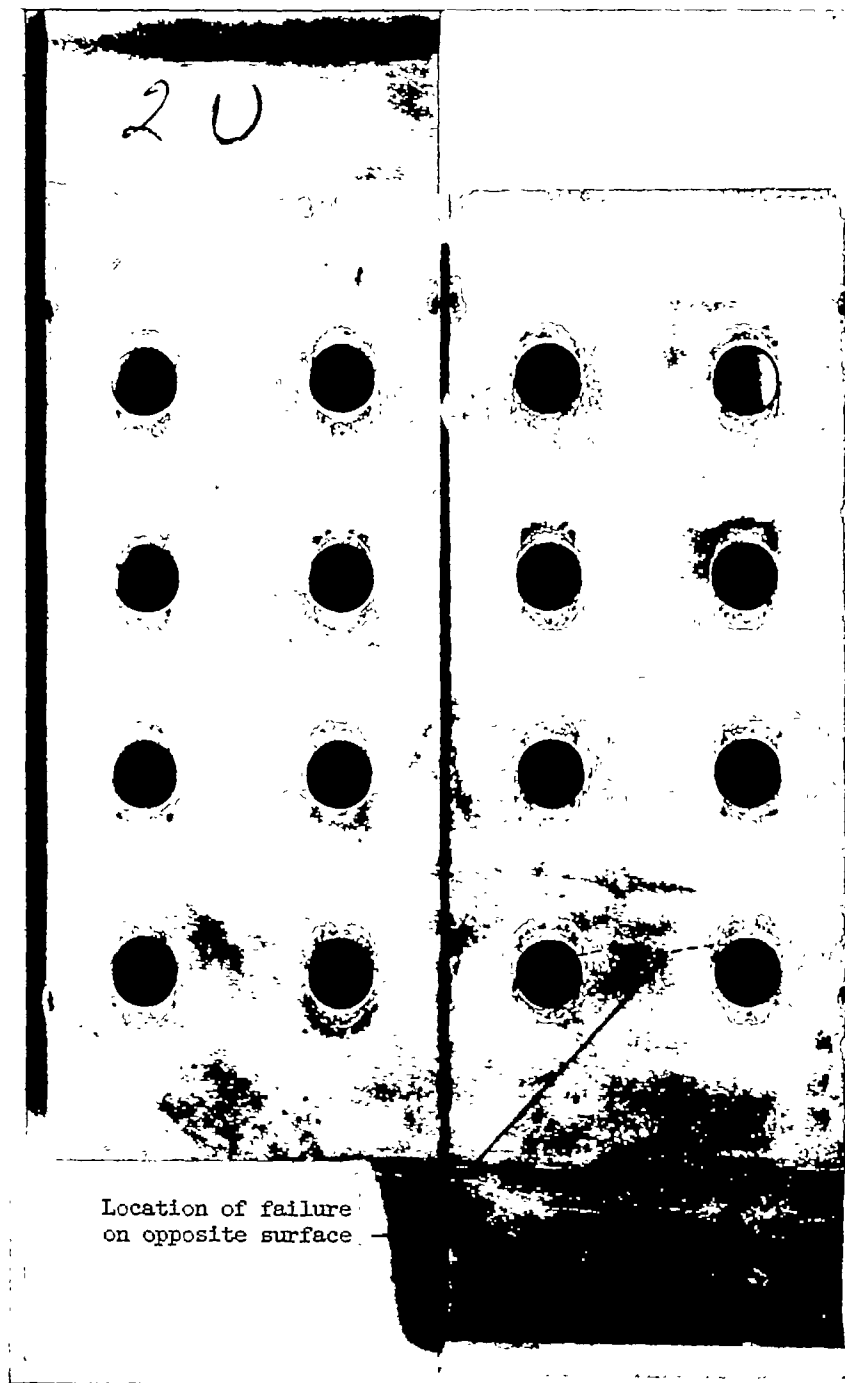
L-83693

Figure 13.- Plastic deformation at bolt holes of faying surfaces of plain-scarf joint which had been loaded to high static loading previous to fatigue test. Photographed after fatigue test. (For views of failure on opposite surface see fig. 14.)

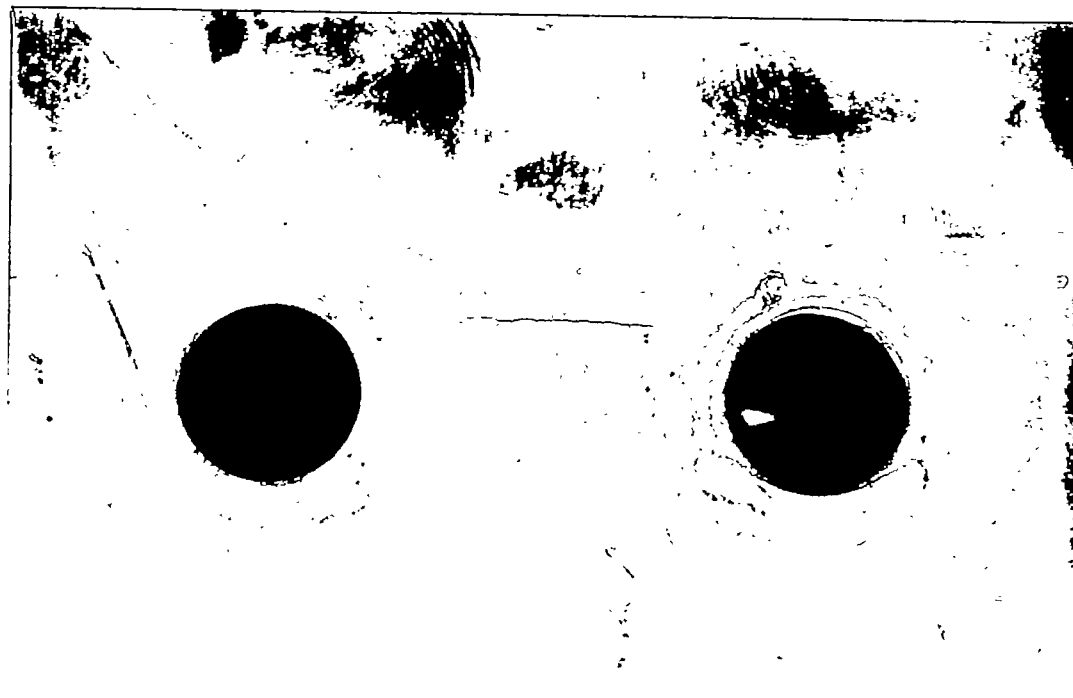
L-83694

Figure 14.- Fatigue failure of plain-scarf joint which has been loaded to high static loading previous to fatigue test. (For location of bolt holes see fig. 13.)

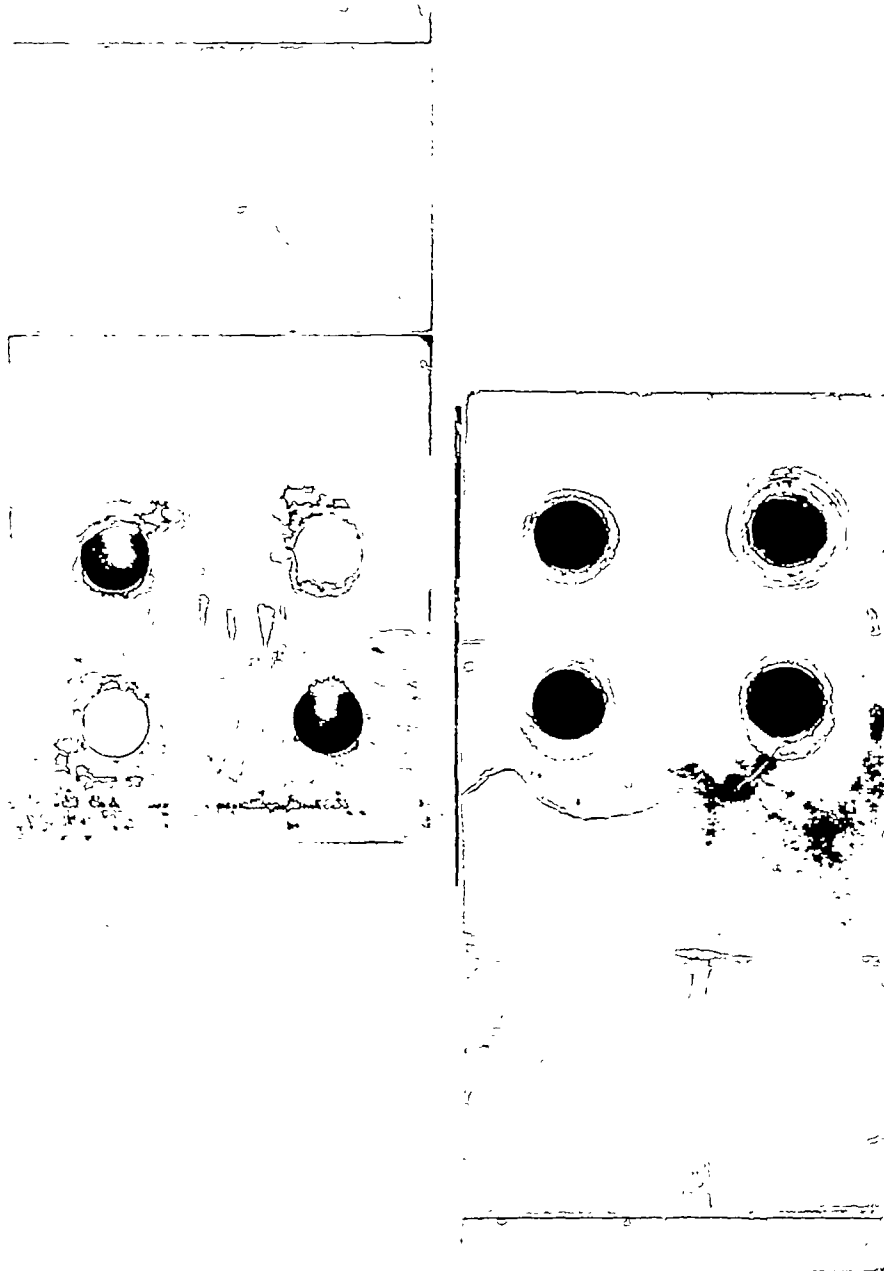
L-83695  
Figure 15.- Fatigue failure in double-shear joint which had been loaded to high static loading previous to fatigue test.

the outside members in a pattern quite unlike that of the corresponding joint without preload shown in figure 15(b) (joint 9B) of reference 1. Figure 16 shows the fractured surface of the preloaded specimen. Metallographic examination indicated that the fracture originated in a fretted area on the faying surface. No sign of additional fractures was evident in the tongue of this specimen. Unless the galling caused some reduction in life of this specimen, it would appear that the location of the critical section in the double-shear joint was changed by the preload imposed with little gain in fatigue life of the joint. It has been said that preloading to 67 percent of ultimate strength increases the fatigue life from two to tenfold. The result of the test on the preloaded plain-scarf joint is in agreement with such a statement. The National Bureau of Standards has reported results of fatigue tests on sheet with static preload (ref. 4) which show beneficial as well as detrimental effects of preloading on fatigue life. It would appear from the two tests made on bolted joints that preloading may or may not have significant beneficial effects on the fatigue life of a joint.

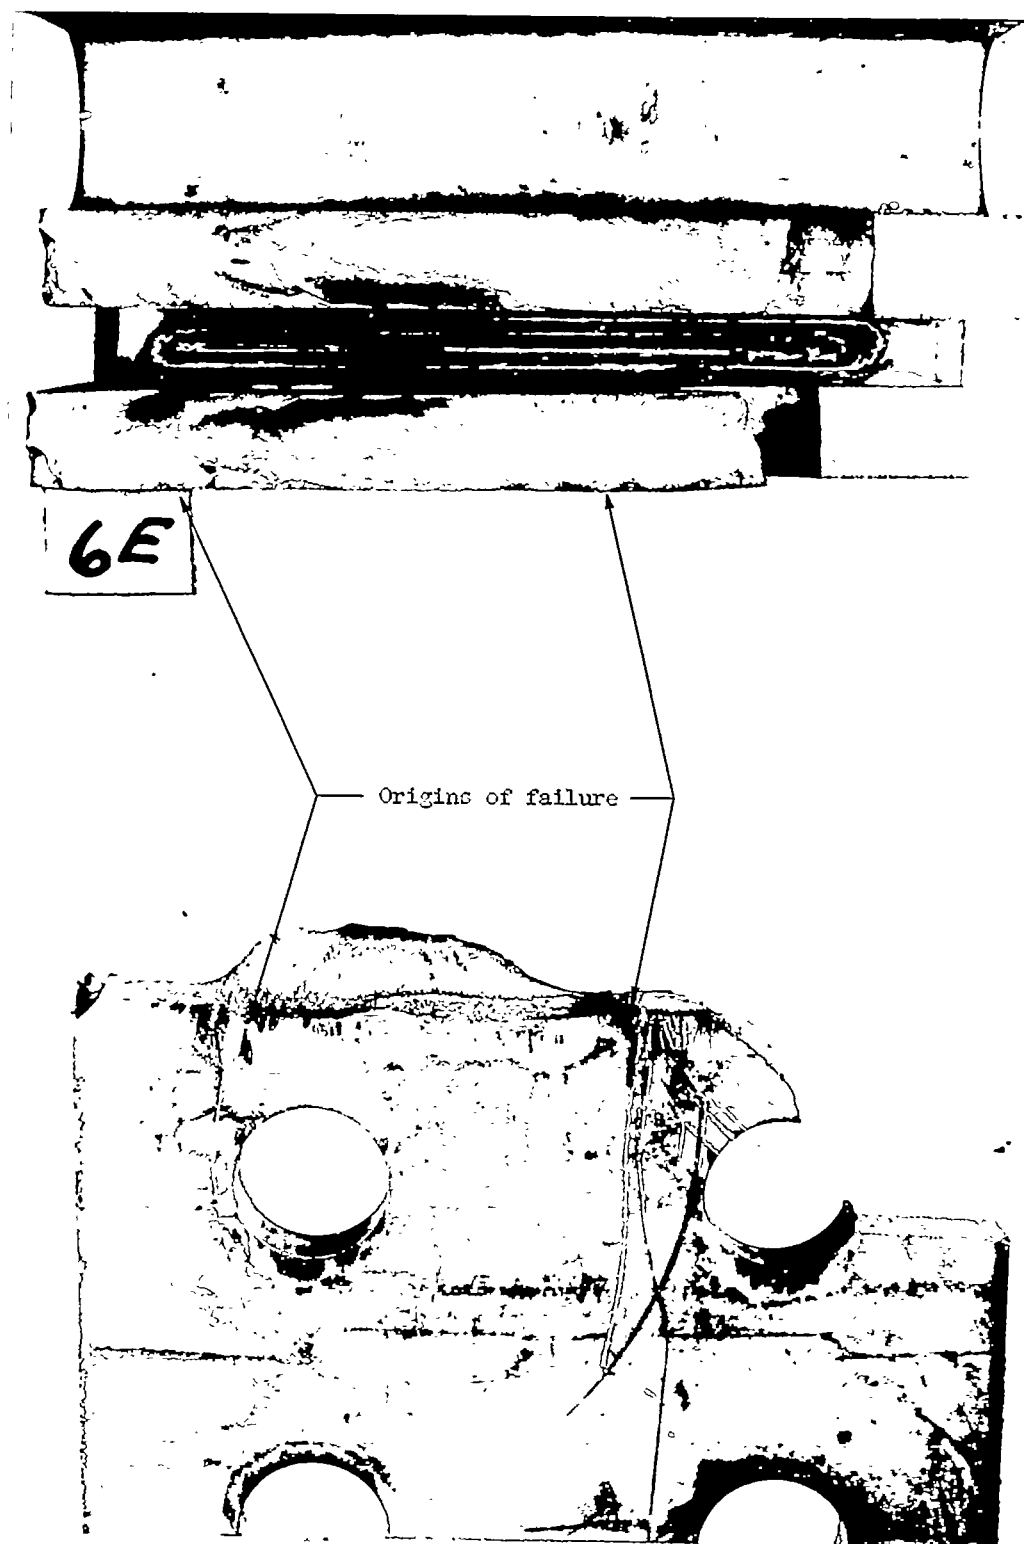
Figure 16.- Failure of double-shear joint which had been loaded to high static loading previous to fatigue test. L-83696
